Harness inspection certificate - EN

Inspection certificate number: **PH_382.2022**

Manufacturer name: **Advance Thun AG**
 Representative: **Rolf Zeltner**
 Street: **Uttigenstrasse 87**
 Post code / place: **3600 Thun**
 Country: **Switzerland**

| Name: | BIPAX 2 | Name Impact pad: ⁽¹⁾ | n/a |

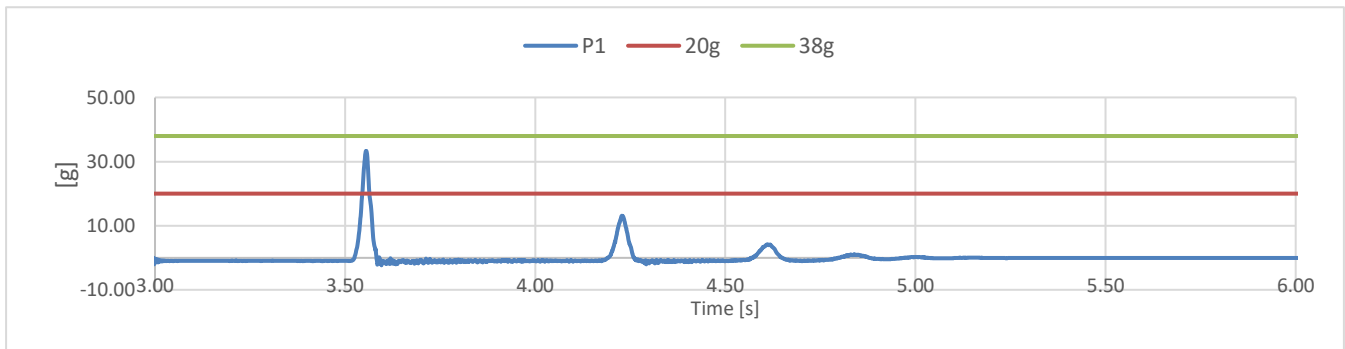
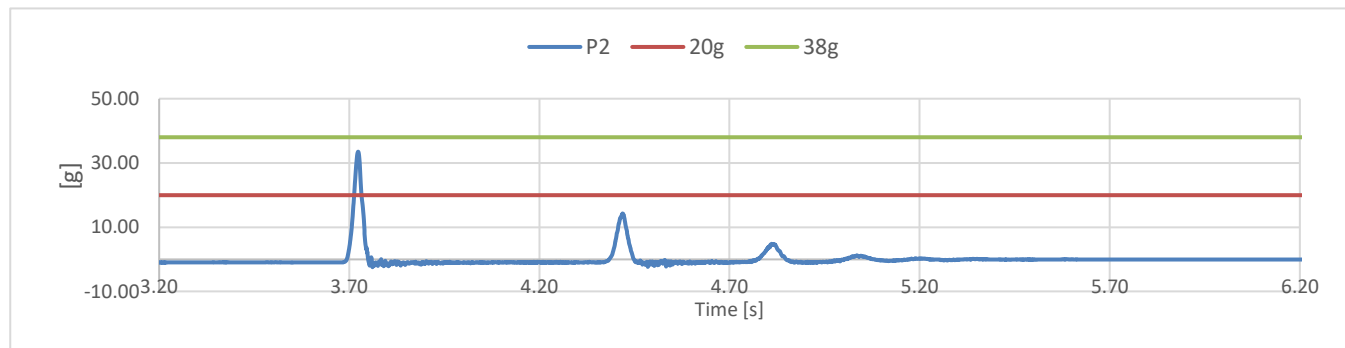
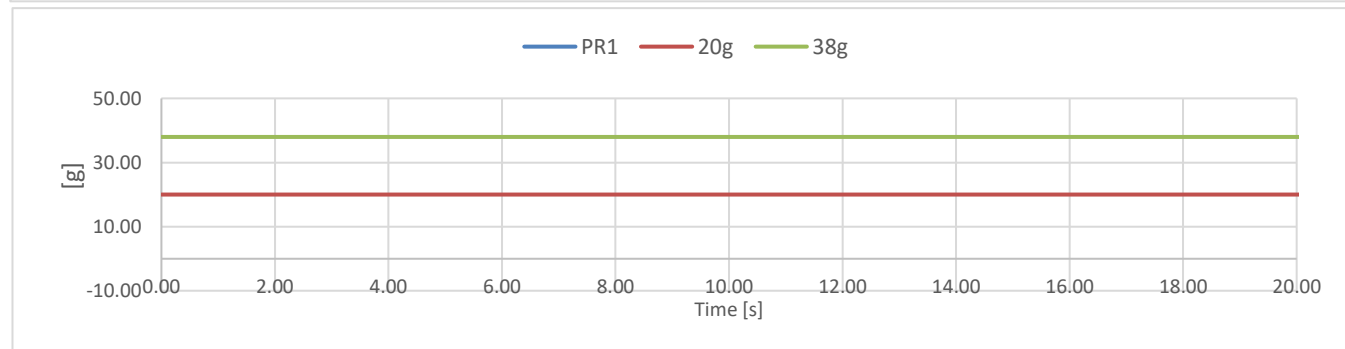
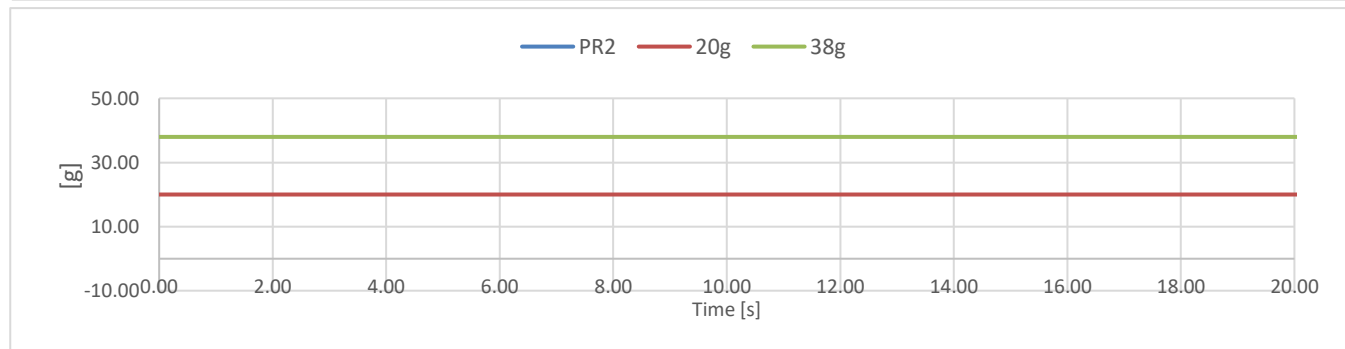
Test results of Impact pad test

| | without emergency parachute | | including emergency parachute | |
|---|---|---|---|---|
| Maximum peak of impact [g] | 35.39 | 35.53 | 0.00 | 0.00 |
| Impact duration at +38 [g] in [ms] | 0.00 | 0.00 | 0.00 | 0.00 |
| Impact duration at +20 [g] in [ms] | 20.00 | 20.83 | 0.00 | 0.00 |

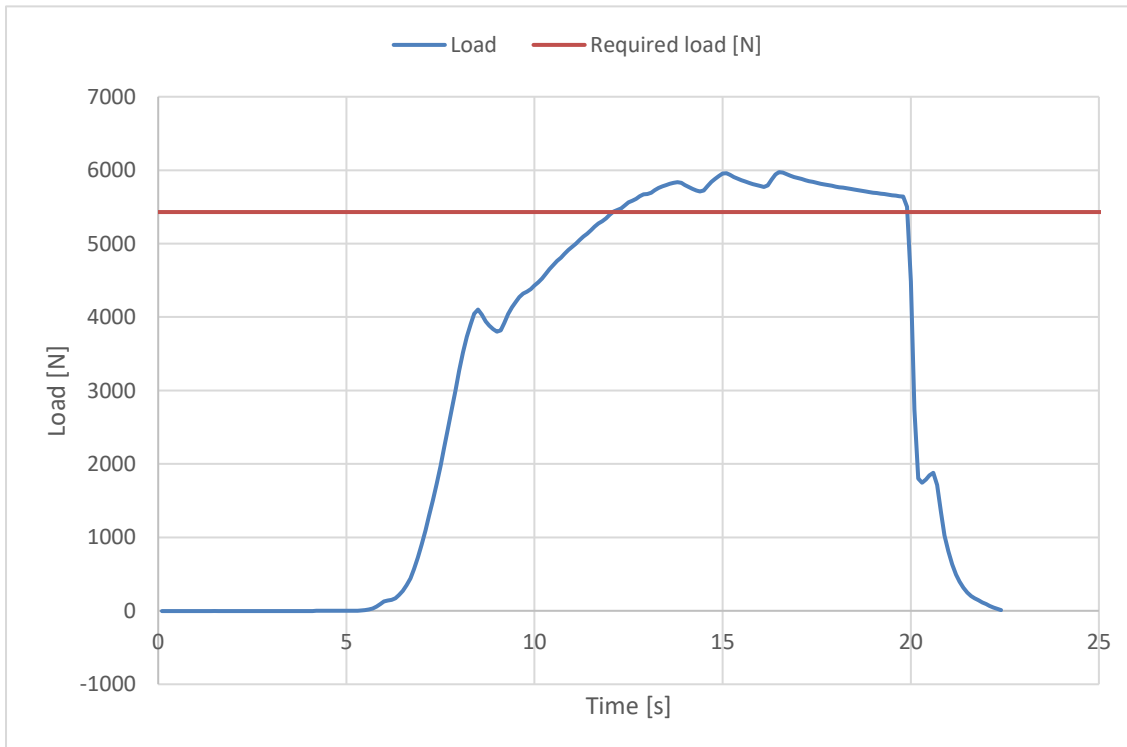
Test ID 01

Test duration [s] **7.9**
 Any signs of structural failure **No**
 Slippery test OK **Yes**
 Test results **POSITIVE**

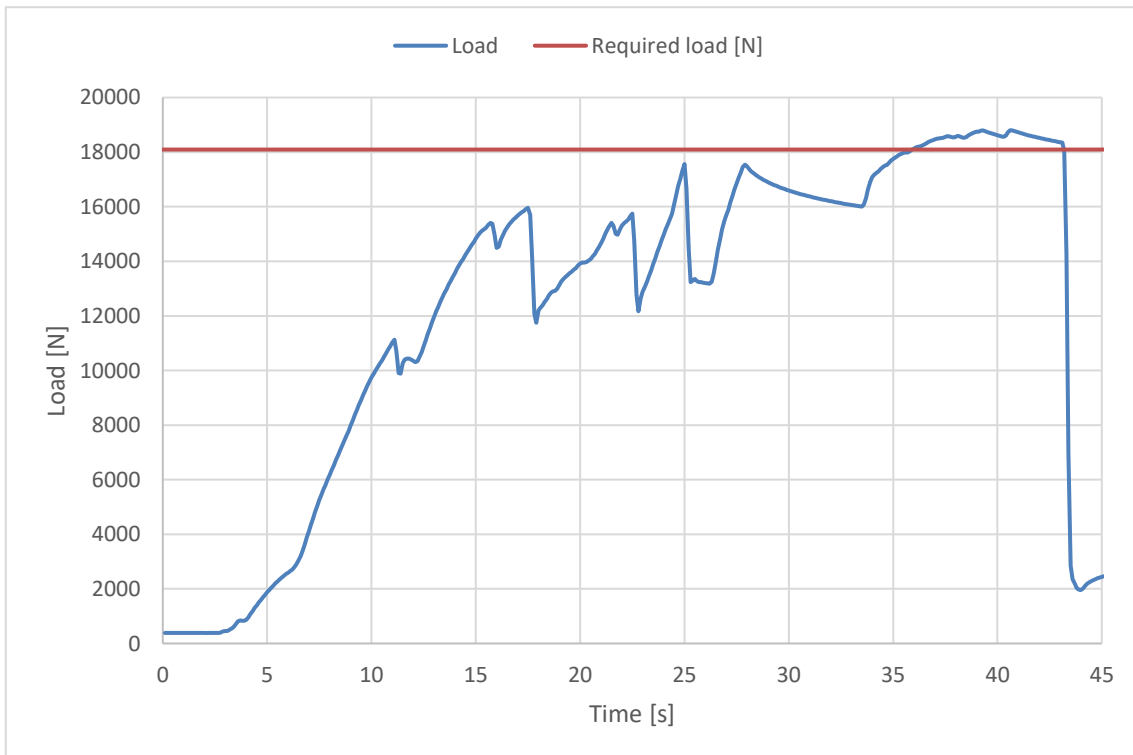
Test ID 03

| Any signs of structural failure | No |
| Test results | POSITIVE |

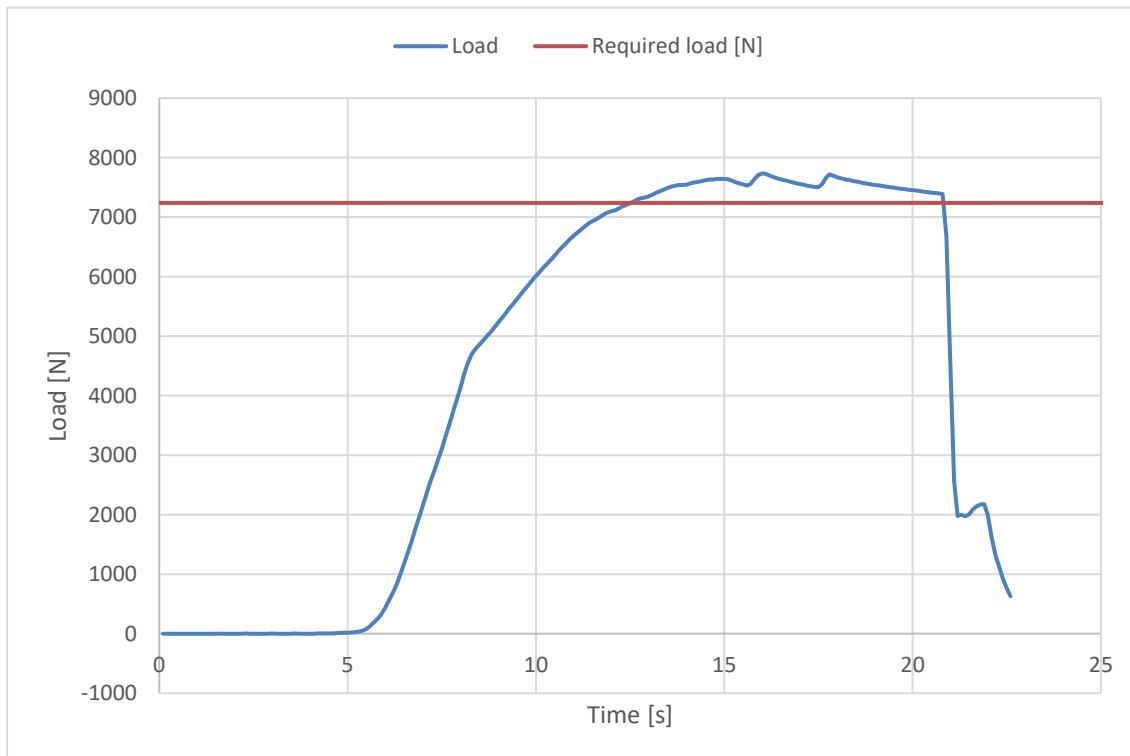
Test ID 05

| Any signs of structural failure | No |
| Test results | POSITIVE |

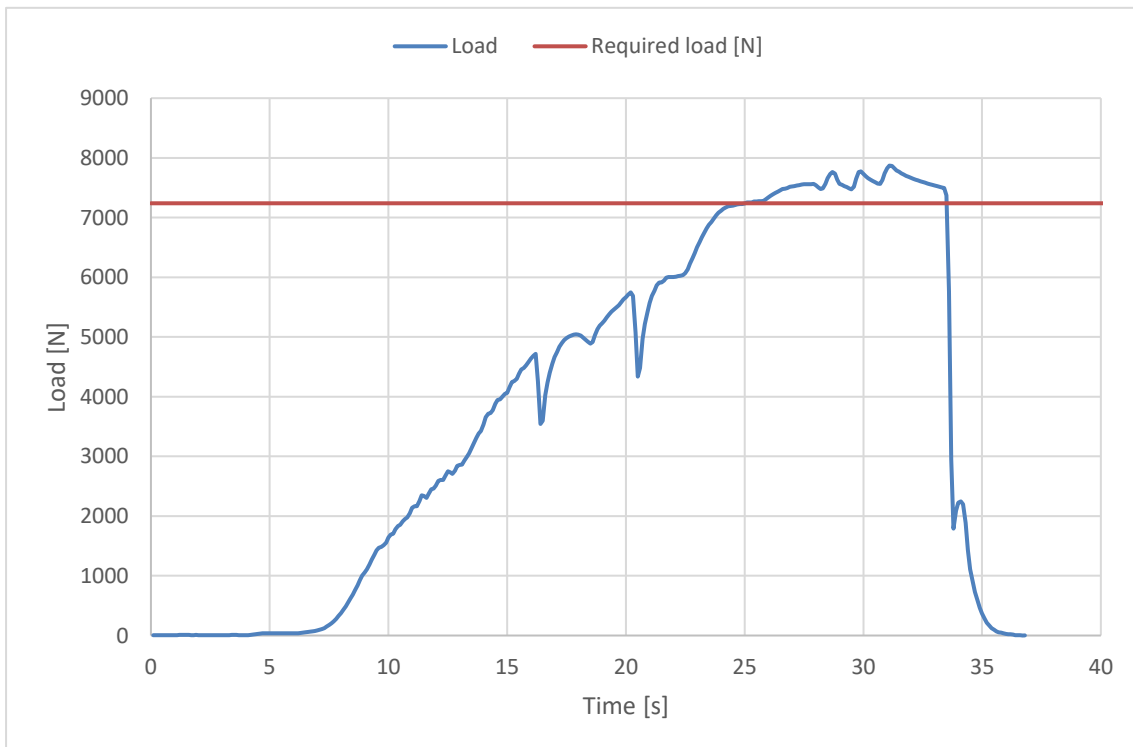
Test ID 06

| Any signs of structural failure | No |
| Test results | POSITIVE |

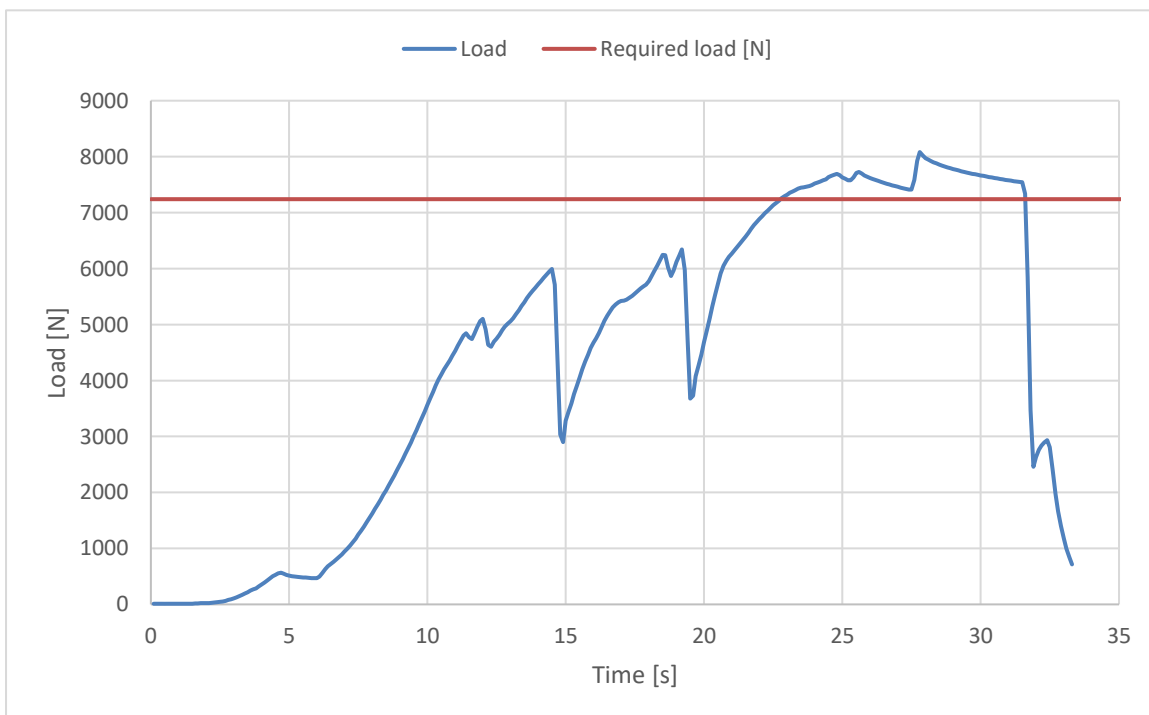
Test ID 12

| Any signs of structural failure | No |
| Test results | POSITIVE |

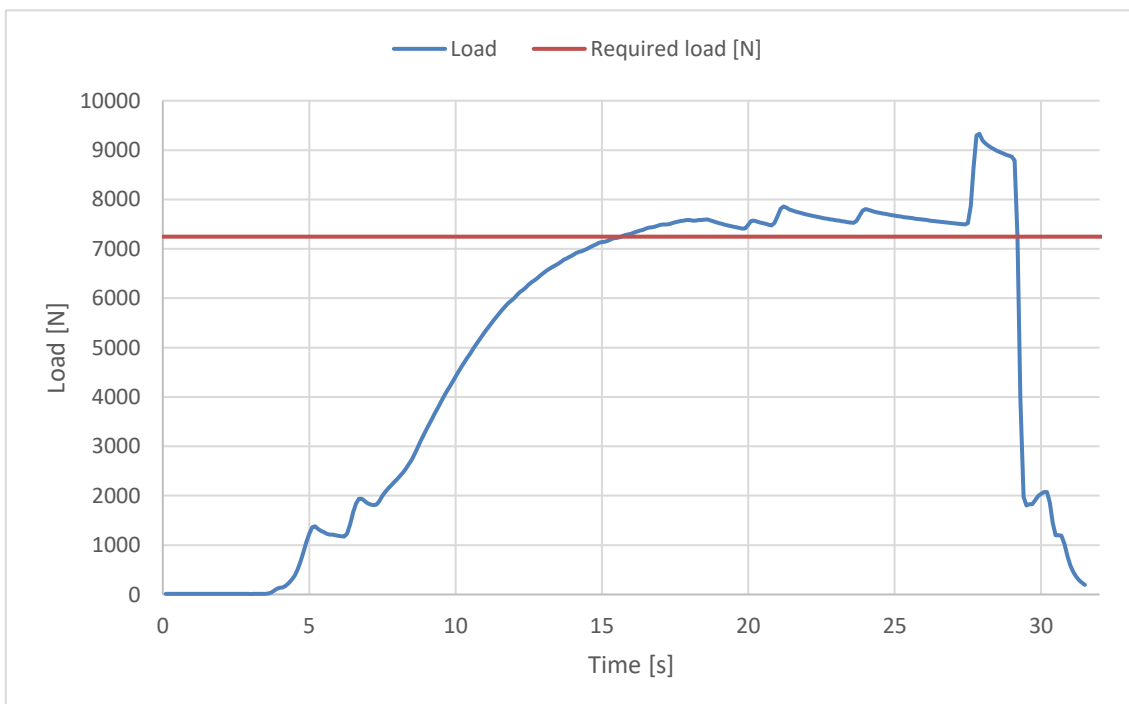
Test ID 02

| Any signs of structural failure | No |
| Test results | POSITIVE |

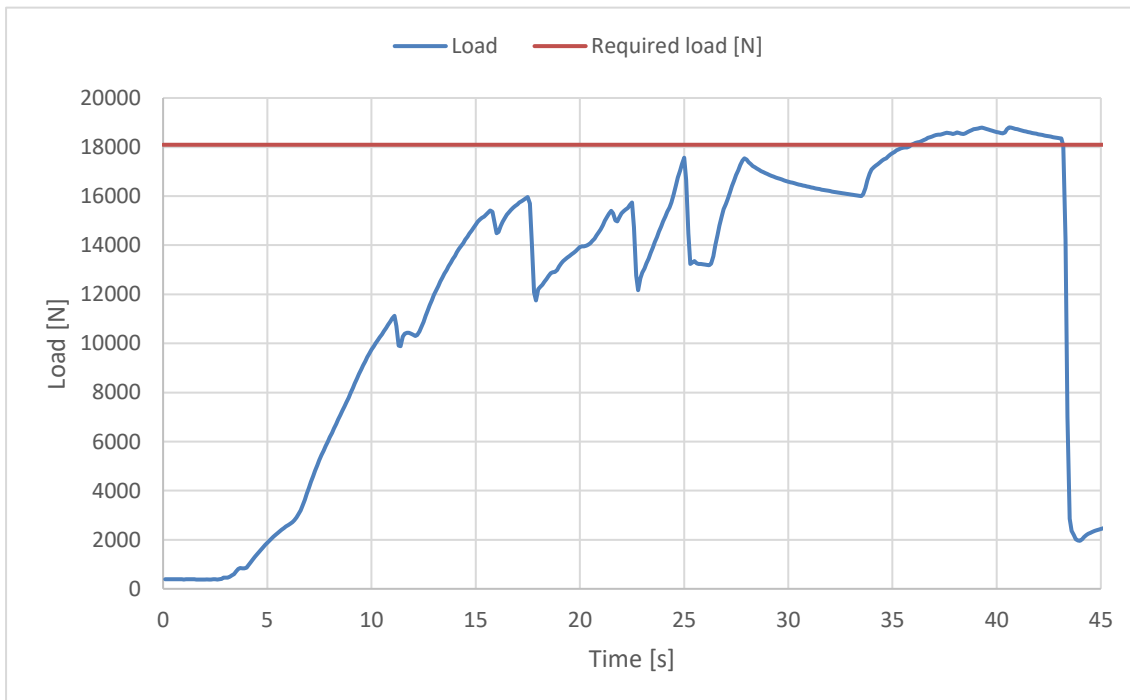
Test ID 03

Test duration [s] **7.2**
 Any signs of structural failure **No**
 Test results **POSITIVE**

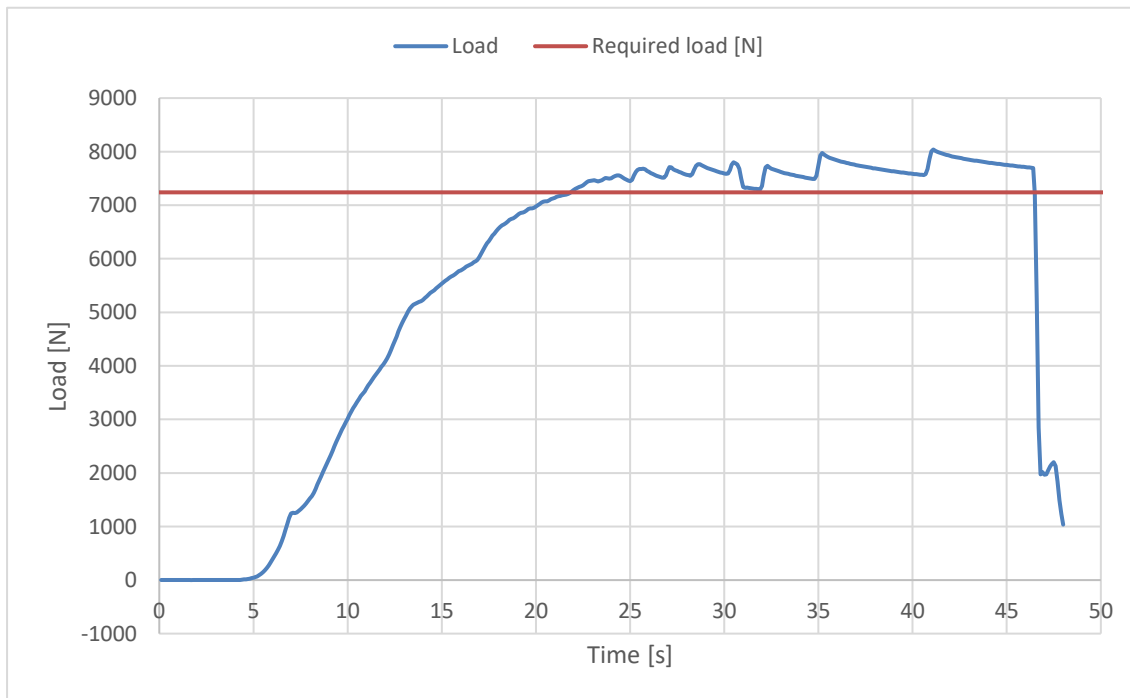
Test ID 04

Test duration [s] **24.6**
 Any signs of structural failure **No**
 Test results **POSITIVE**
